Manhole Inspection Summary

Manhole # S17II_015MH

Location Address: **2327 NORTH-WESTWOOD**

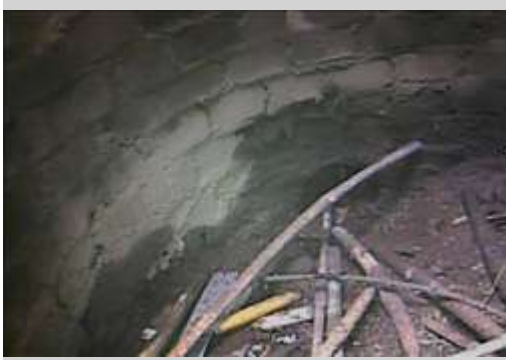
Defect 2

Infiltration: ☐ None ☐ Joint ☐ Cracks ☐ Mortar ☐ Roots ☒ **Wall**

INFILTRATION OF BARREL

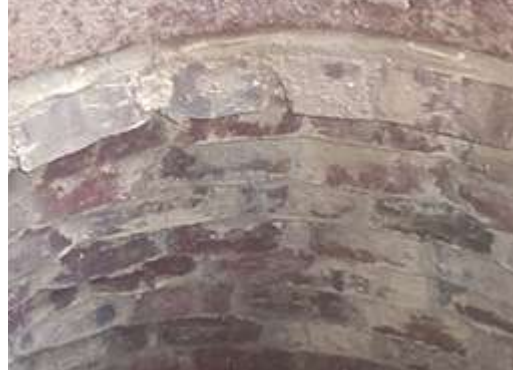
Defect 1

Condition: ☐ Sound ☐ Cracked ☐ Root Intrusion ☐ Loose Brick ☒ **Deteriorated**

DETERIORATION OF CHIMNEY

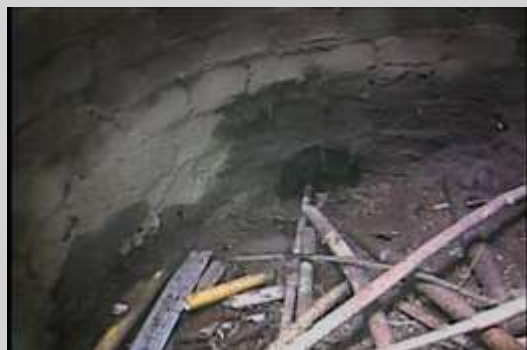
12 O'Clock Outflow

BARREL INFILTRATION
